ADVANCED TURBINE SUPPORT

**MS7001FA AFT-TRANSITION PIECE MOUNTING BRACKETS
AND IMPINGEMENT SLEEVE INSPECTION RECOMMENDATIONS**

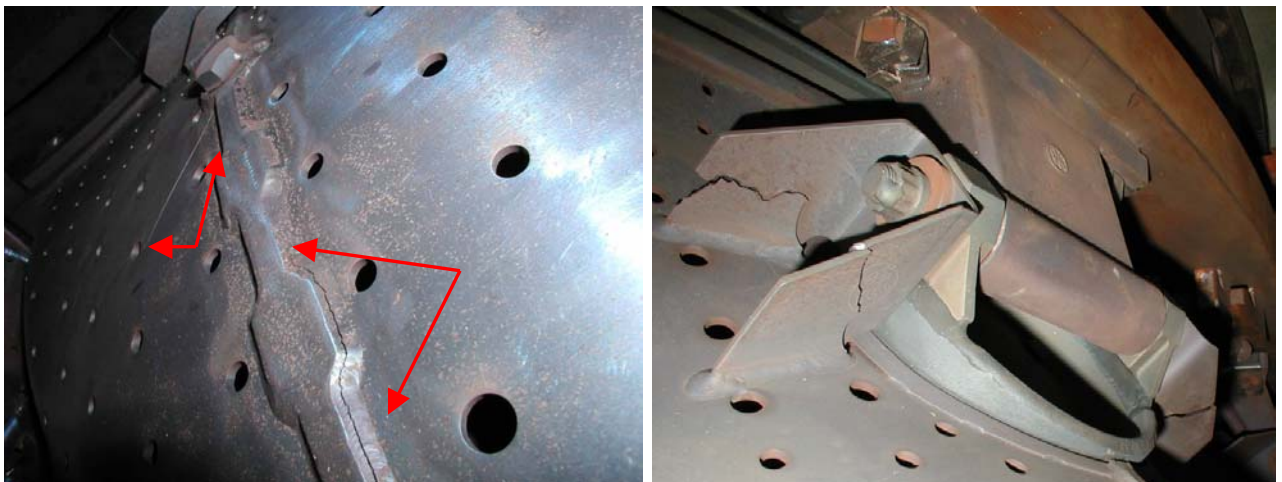
Recent findings have identified significant cracking on the impingement sleeve on the inner side, opposite from the aft-mounting brackets. In some cases pieces of the impingement sleeve were missing.

These views are showing multiple cracks on the interior side of a transition piece and cracks in the aft-transition piece mounting brackets.

Perform a borescope inspection of all fourteen aft-mounting brackets and the impingement sleeves at the earliest convenience.
