***ADVANCED TURBINE SUPPORT***

**MS7001FA STAGE 14 ROTOR BLADE TIP FAILURE**

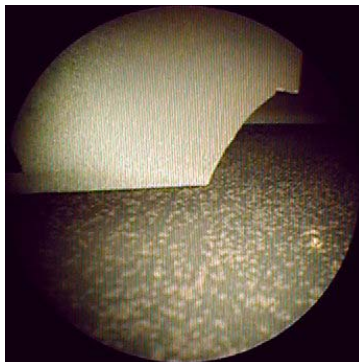
On a number of units the stage 14-R rotor blades are experiencing tip failures similar to those occurring on other stages of the compressor. These appear to be caused by the rotor blades contacting the compressor case. This causes the metal along the tip to overheat and become brittle. During one of our inspections we identified as many as twenty-five tip failures on one 7FA compressor.

This is a stage 14-R tip failure

Perform a borescope inspection of every stage 14 rotor blade to assess if tip failures have occurred or if rolled metal is present on the blade tips.

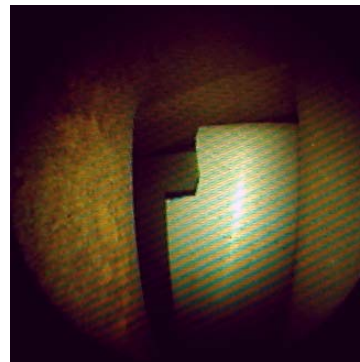
This is another stage 14-R tip failure

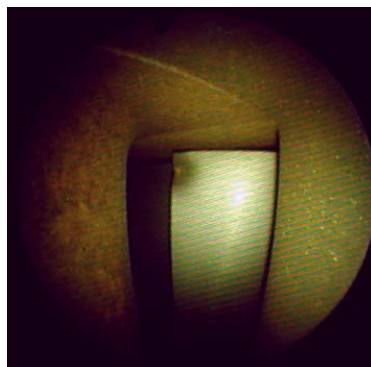
This is collateral impact damage on a stage 14-rotor blade.

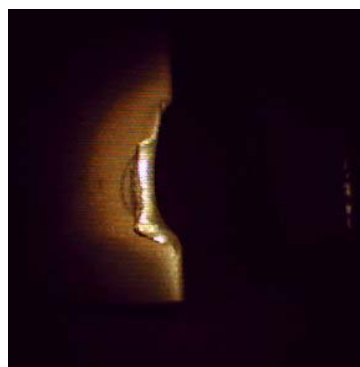
This is collateral impact damage on a stage 16-rotor blade.
