Advanced Turbine Support Newsletter 3

April 28, 2004

MS7001FA STAGE 0-R AND 1-R BLADE TIP DISTRESS

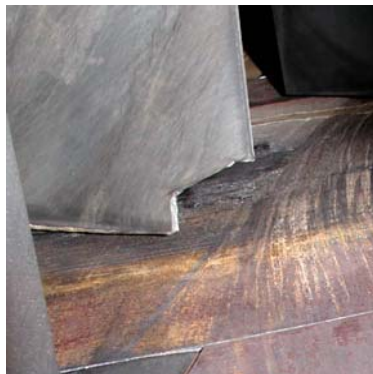
This view is showing a stage 0-R tip failure.

Perform a visual inspection of the stage 0-R and 1-R blade tips by utilizing a borescope or using a flashlight. The inlet guide vanes should be stroked open to allow a visual inspection of as many blade tips as possible. If any gray or black discoloration is evident or blade tips are missing a remote penetrant test should be scheduled at the earliest opportunity. If a cracked blade tip is identified we can either remotely remove the blade tip or an outage can be scheduled through your normal channels.

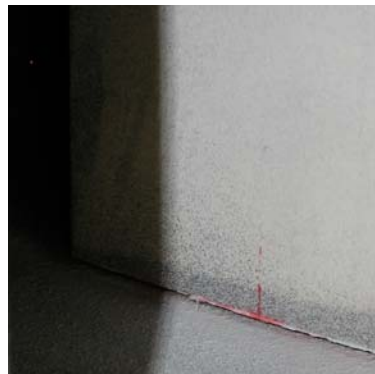
This view is showing a cracked stage zero rotor blade.

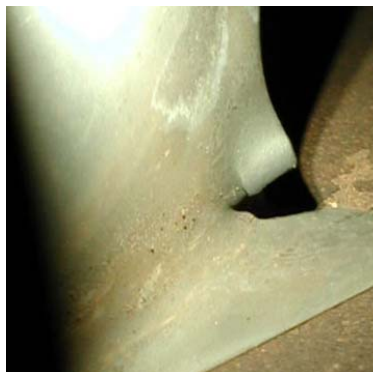
This view is showing collateral damage to a stage zero stator vane.

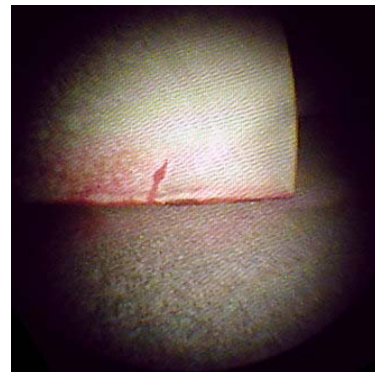
This view is showing a cracked stage one rotor blade.
