***ADVANCED TURBINE SUPPORT***

**MS7001FA STAGE 17-S VANE DISTRESS**

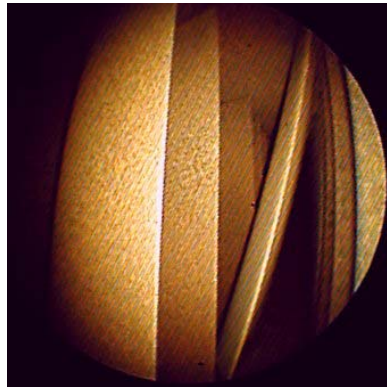
This view is showing a stage 17-S vane failure.

Perform a remote visual inspection of every stage 17-S stator vane. We are also currently assisting in the development of a specialized videoscope that will allow us to perform remote fluorescent dye penetrant testing of the stator vanes. In our experience the majority of the stator vane failures have occurred between the 12:00 to 3:00 o'clock positions on the unit. Initially the remote penetrant testing will be limited to this area.

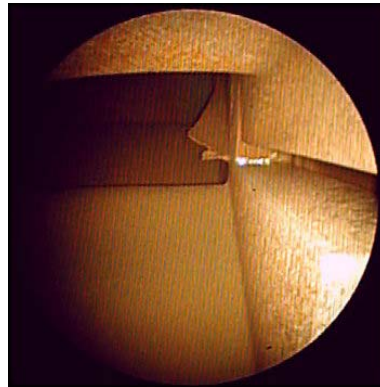
This view is showing another stage 17-S vane failure.

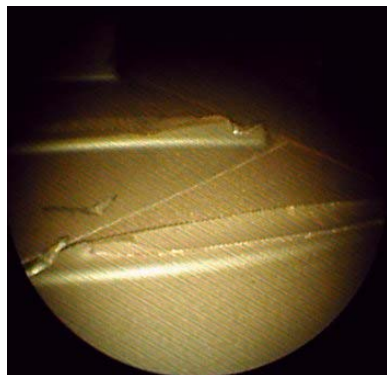
This view is showing two stage 17-S vane platforms.

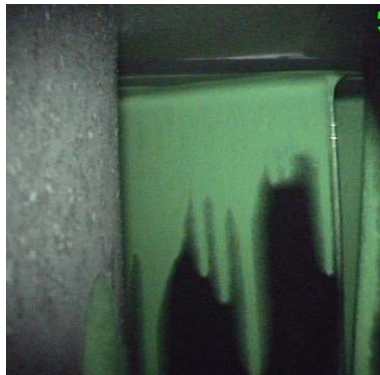
This view is showing a stage 17-S vane being tested remotely using fluorescent dye penetrant.
