ADVANCED TURBINE SUPPORT

WESTINGHOUSE 501F: COMPRESSOR STAGE 1-R BLADE TIP DISTRESS

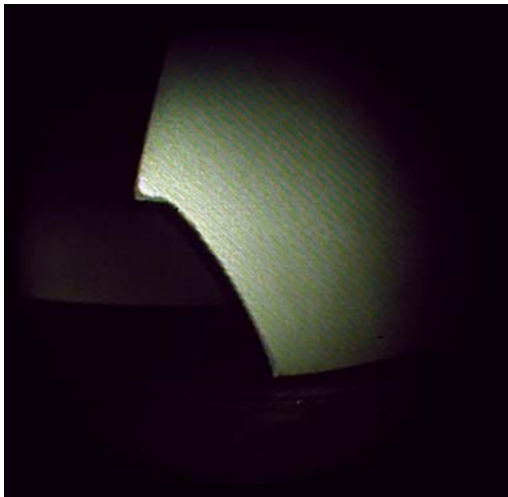
This view is showing a stage 1-R rotor blade tip failure.

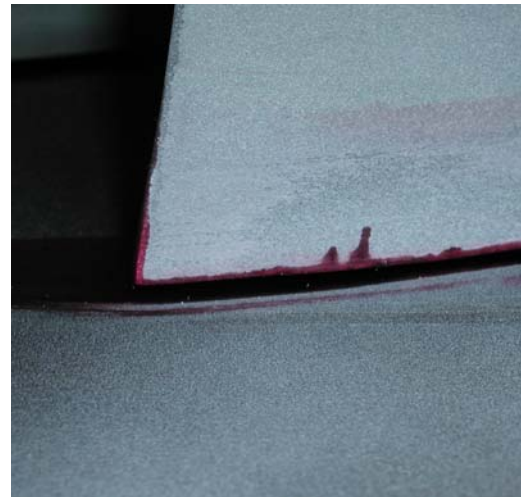
This view is showing a stage 1-R rotor blade tip crack identified using dye-penetrant testing.
