ADVANCED TURBINE SUPPORT

MS7001FA FIRST STAGE TURBINE BUCKET CRACKING

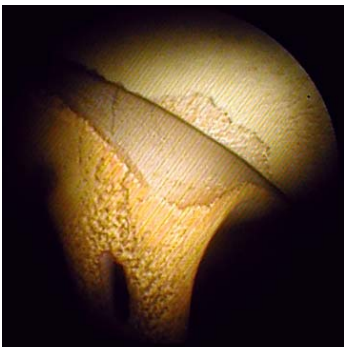
We have identified turbine bucket cracks on the first stage bucket platforms. This cracking initiates at the pressure-side platform and or the trailing edge platform. We are identifying cracks or linear indications on 90% of the units we inspect.

Trailing edge platform indication.

Users should have ATS inspect the leading and trailing edge of each first stage bucket using ultra-close up technology. This inspection will verify the presence or absence of cracking. If cracks are found this information should be submitted to General Electric engineering for disposition.

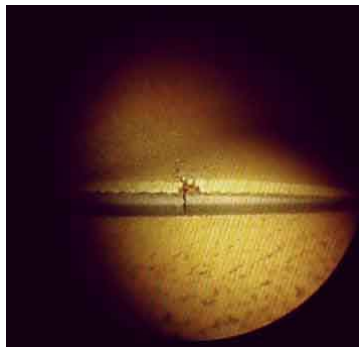
Platform crack in TBC coated bucket.

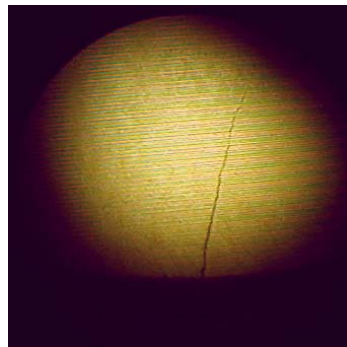
Platform crack in a non-TBC coated bucket.

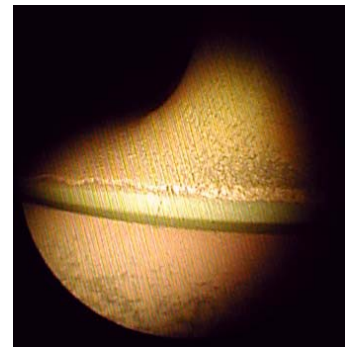
Faint platform indication.
