ADVANCED TURBINE SUPPORT

MS5001 INLET GUIDE VANE CRACKING

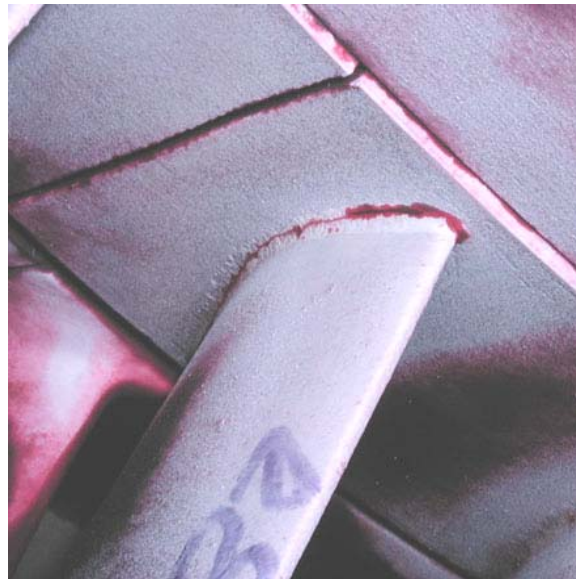
We have identified several units that had inlet guide vane cracking at the inner radius.

This is a close up view showing a cracked inlet guide vane. This cracked vane was one of seven identified by penetrant testing on this unit.

During an ATS borescope inspection of a frame 5 with fixed inlet guide vanes the inner radius IGV attachment should be visually inspected using 10X magnification. Any questionable indications should be tested using liquid dye penetrant testing. If cracking is identified on the IGV's a maintenance outage should be planned to weld repair the vanes.
