Advanced Turbine Support

MS7001FA Lift Oil Line Failure

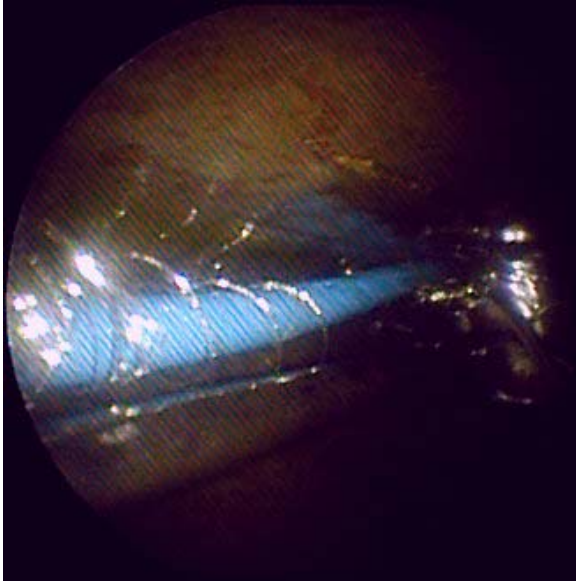
This photograph shows where the stainless braid has failed on one of the lift oil lines.

Users should have ATS perform a borescope inspection of the lift oil lines at the earliest opportunity.

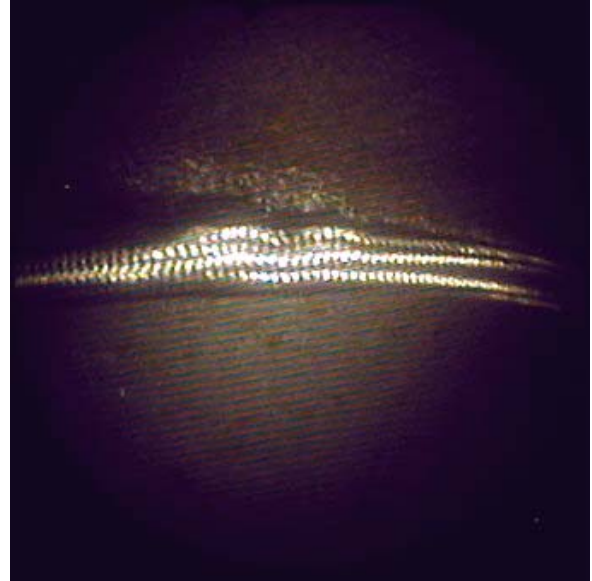
This photograph shows a budge in one of the lift oil lines.
