ADVANCED TURBINE SUPPORT

MS7001FA S-1 Stator Vane Failure

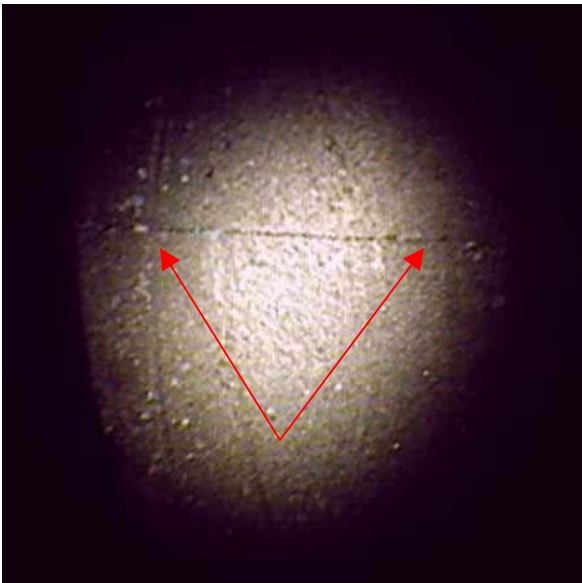
There have several recent total compressor failures related to S-1 stator vane tip liberations. The root cause of these failures appears to be caused by the locking up of the stator vanes in the lower half of the unit due to corrosion. This “lock-up” is causing high-cycle fatigue near the vane tip.

This photograph shows a crack in an S-1 stator vane located approximately 2.2” below the tip. This unit had approximately 500 starts and 6000 hours at the time of inspection.

Users should perform Eddy Current Inspections of the lower stator vanes as soon as possible. The inspection time is approximately 12 hours.

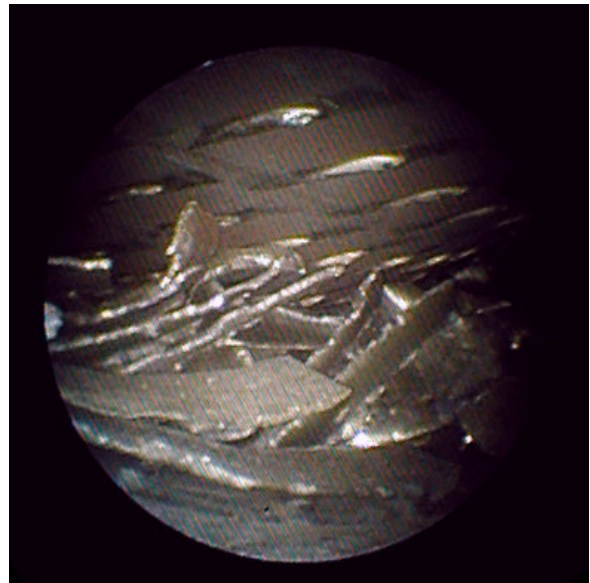
This shows the damage that can occur when a piece of stator vane goes through the compressor.
