Advanced Turbine Support

MS7001FA S-1 Stator Vane Failure

UNIT TYPE: MS7001FA.

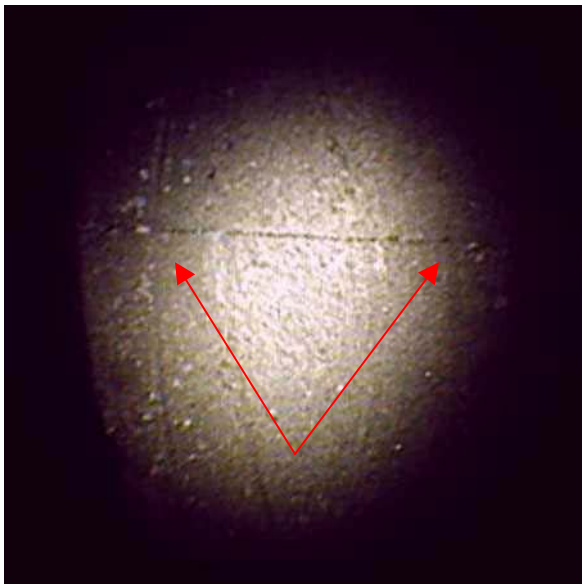
This photograph shows a crack in an S-1 stator vane located approximately 2.2” below the tip. This unit had approximately 500 starts and 6000 hours at the time of inspection.

Users should have ATS perform Eddy Current Inspections of the S-0 and S-1 stator vanes as soon as possible. The inspection time is approximately 12 hours.

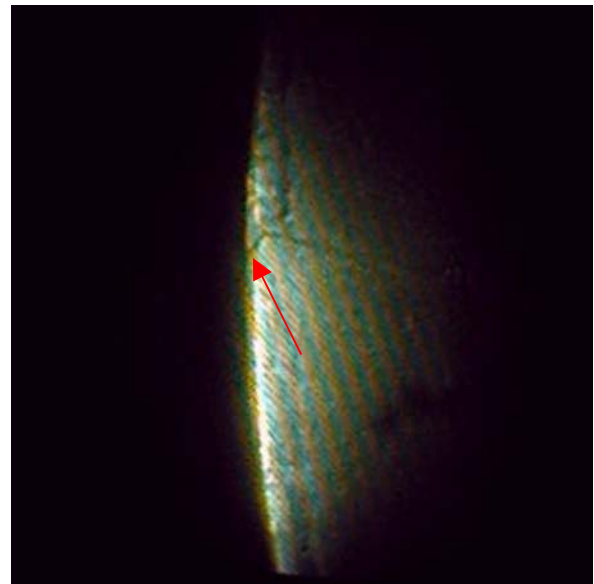
This shows a crack extending into an S-1 stator vane that initiated at minor impact damage. Minor impact damage is seen on the majority of the compressors we inspect using the high-resolution inspection.
