Advanced Turbine Support

General Electric 7FA: Dovetail cracking on the standard R-0 blades.

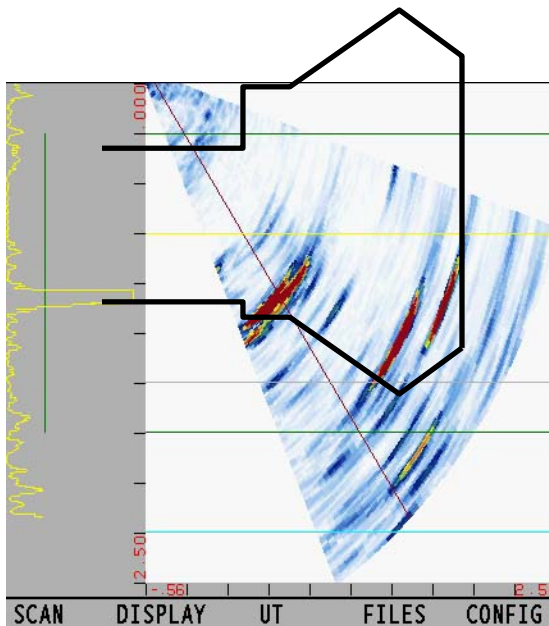
7FA Standard R-0 blade on unit 1 with a 1.8" dovetail crack.

Perform a phased array ultrasonic inspection of the R-0 and R-1 blade platforms as soon as possible. Any fretting indications found should be monitored on a 15-start interval.

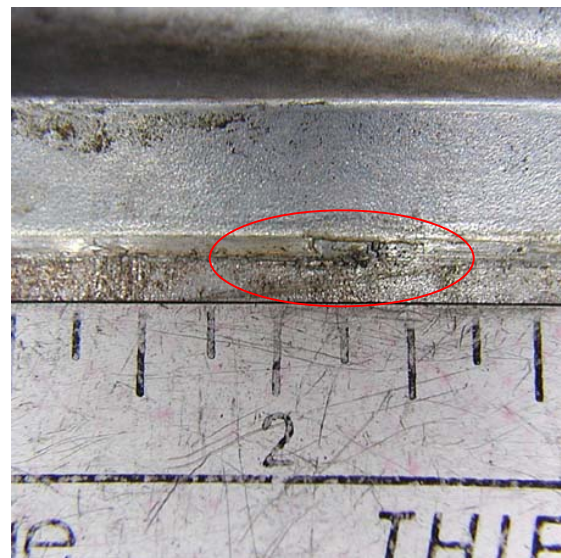
This close-up photograph shows where a crack was identified on unit 2. The crack was verified using UT in place and ET when removed. Best viewed at 200% zoom.
