## Advanced Turbine Support

### General Electric 7FA: Dovetail cracking on the standard R-0 blades.

**UNIT TYPE** MS7001FA

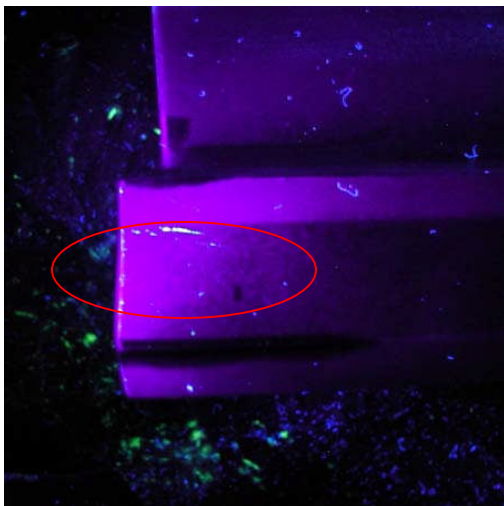
This photograph shows a crack on the pressure side, trailing edge platform area on the stage R-0 rotor blade # 10 seen with a black light.

Perform a phased array ultrasonic inspection of the R-0 and R-1 blade platforms as soon as possible. This testing should be supplemented with straight beam testing to identify cracks in the new failure location. Any testing done prior to September 28<sup>th</sup> should be repeated using this new testing method. Any testing done after this date by Advanced Turbine Support, Inc. has incorporated the new testing and does not need to be repeated until the next scheduled inspection cycle. FPI is not required if using the updated UT inspection.

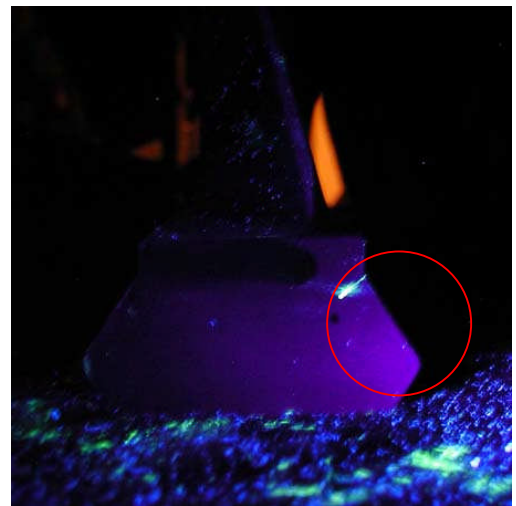
This photograph shows a crack on the aft side of the stage R-0 rotor blade # 10 seen with a black light.
