Advanced Turbine Support

MS7001FA Stator Vane Cracking

This newsletter addresses the MS7001FA.

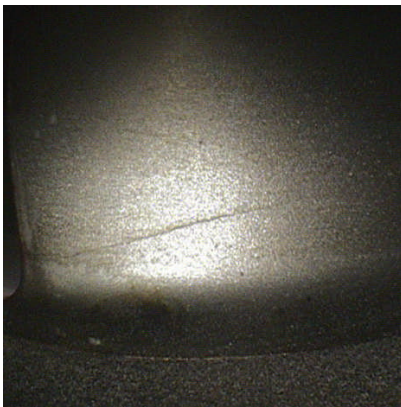
This photograph shows a crack in the trailing edge of an S-0 stator vane.

Until the Eddy Current inspection can be performed we recommend users should perform a visual inspection of the stator vanes using a mirror and flashlight as soon as practical. Any suspect indications should be dispositioned using eddy current. Perform a full eddy current of the S-0 leading and trailing edges plus the S-1 leading edges as soon as possible. Perform an ECI of as many S-2 and S-3 leading edges as possible. We can normally get at least 25% of these stages. The remaining vanes are inspected using the high resolution videoscope. Some of the S-0 cracks we have found could only be identified using ECI so this inspection should be performed as soon as possible.

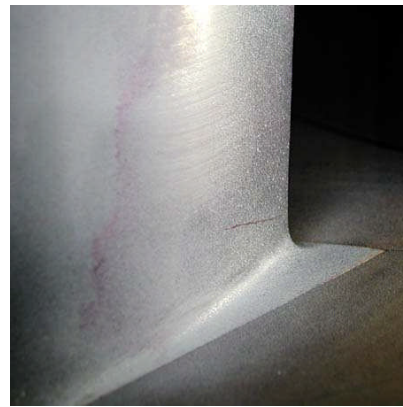
This photograph shows a crack in the trailing edge of an S-0 stator vane after dye penetrant testing.
