Advanced Turbine Support

501F Row 2 Blade Failures

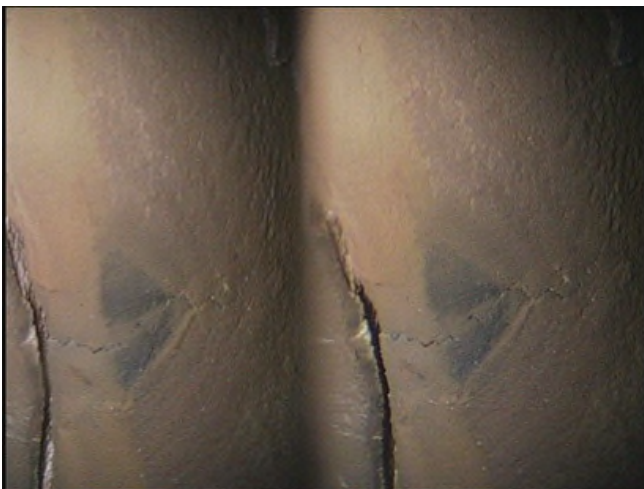
This photograph shows a crack in the trailing edge of a row two blade. This unit had 7658 Total Hours at the time of the inspection.

Users should have Advanced Turbine Support, Inc. perform a close up visual inspection of the leading and trailing edges of the row two blades as soon as possible. This testing can identify very small cracks in the leading and or trailing edges of the blades before the liberation of the blade. This inspection requires approximately 14 hours to complete. During this inspection we will need the turbine borescope plugs removed and have the ability to rotate the unit slowly so we can inspect each blade.

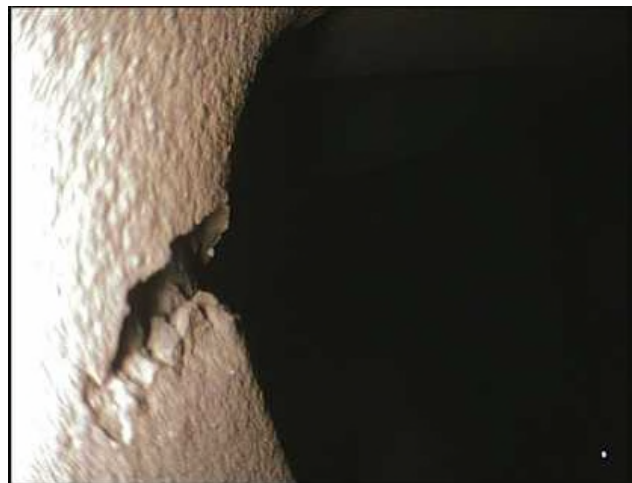
This photograph shows a crack in the trailing edge of a row two blade. This unit had 22135 Total Hours at the time of the inspection.
