ADVANCED TURBINE SUPPORT

MS5001 BLEED AIR HOOK FIT CRACKING

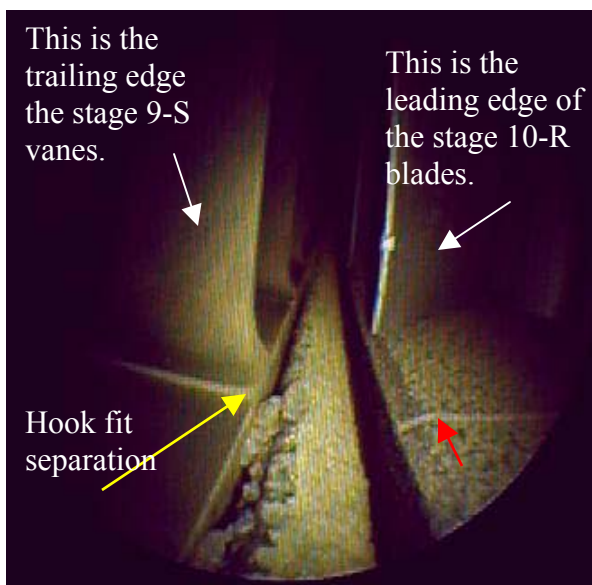
This view is showing a unit with a cracked hook fit before a total failure. The red arrow designates the case break.

Users should have ATS perform a borescope inspection of their units as soon as possible. If cracking is identified at the bleed air slot a maintenance outage should be planned to replace or repair the compressor.

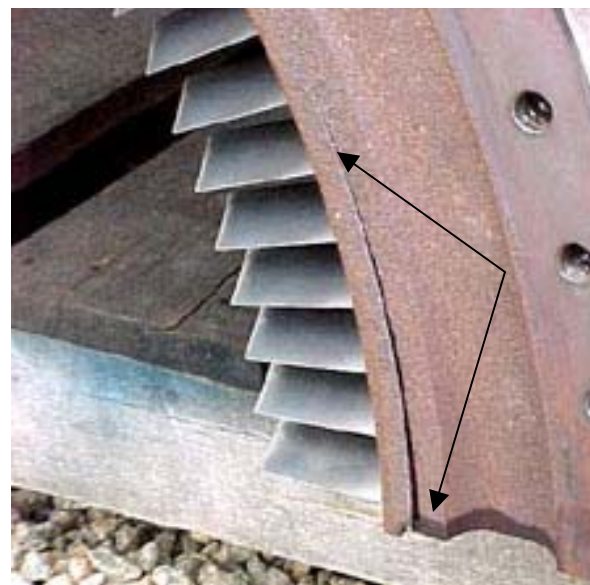
This is a general view showing how the hook fit cracking typically starts at the case break and propagates around the unit until a total failure occurs.
